Vehicle Control Unit (VCU) for the HMMWV

Background of HMMWV Starting Problems

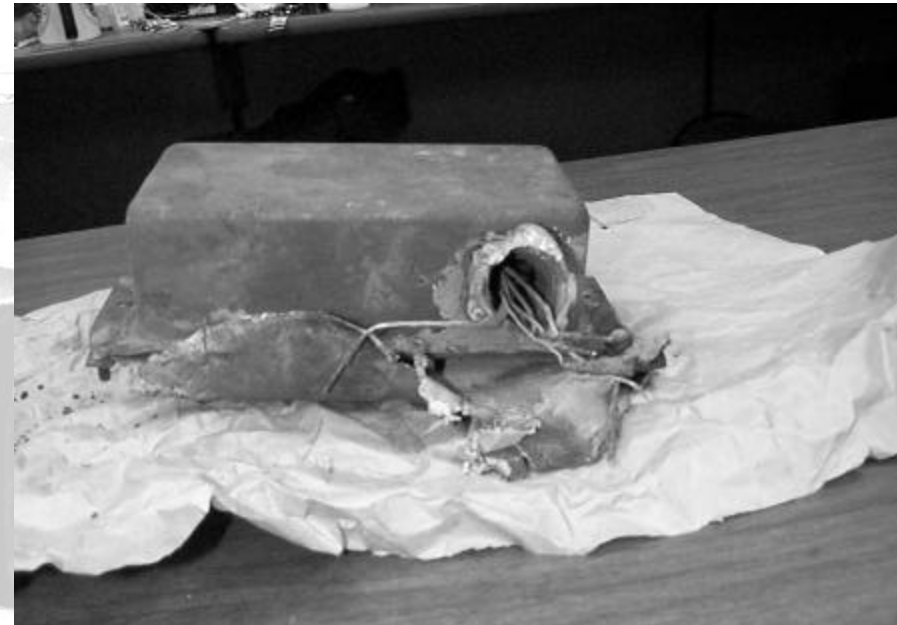
Protective Control Box (PCB) : The Main Problem

- **Most Failed Item** in the Army's Inventory:
 - **25,000 PCBs Failed** Every Year (\$150/Box)
- **PCB Failures Caused:**
 - **480,000** Glow Plugs to Fail Every Year (\$4.50/Plug)
 - **72,000** Glow Plug Controllers (GPC) to be Replaced Every Year (\$45/Controller)
